Manhole Inspection Summary

Manhole # S57I__018MH

Insp Date: **7/2/08 9:06 AM**

Location Address: **4013 eastern ave**

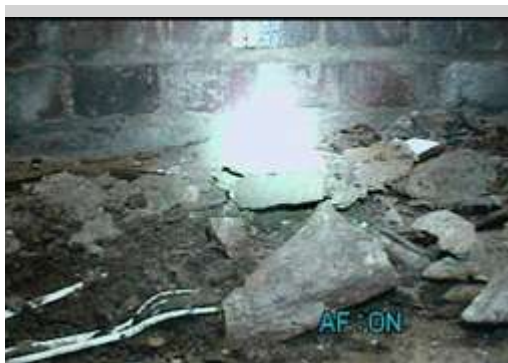
Defect 4

Condition: ☐ Sound ☐ Cracked ☐ Root Intrusion ☐ Deteriorated ☐ Leaks ☒ **Debris**

bench debris

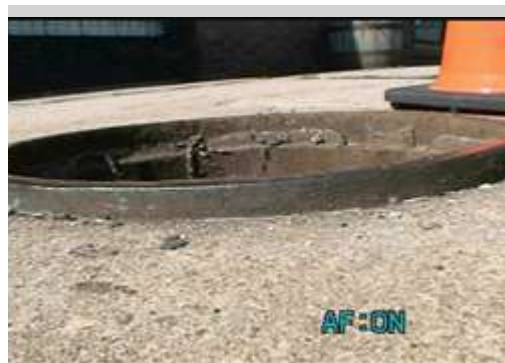
Defect 3

Cover Shape: **Circular** Diameter: **26** (in.) Length: **0** (in.) Dist A/B Grade: **2** (in.)

above grade

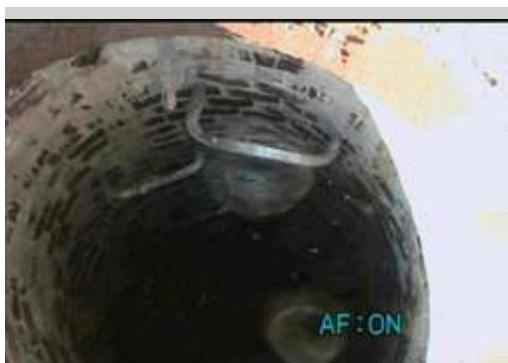
Defect 2

Steps Count: **5** Missing: **0** ☒ **Corroded**

corroded & missing steps

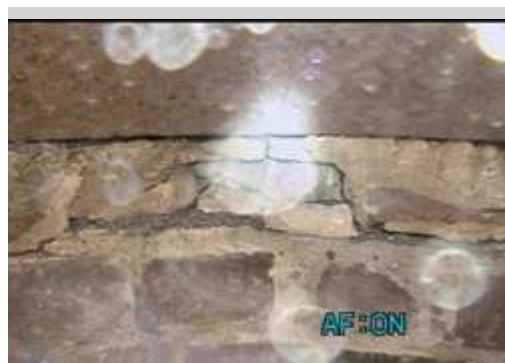
Defect 1

Chimney / Frame Adjustment ☒ Exists Material: **Brick and Concrete** ☐ Parged Height: **3** (in.)

Condition: ☐ Sound ☒ **Cracked** ☐ Root Intrusion ☒ **Loose Brick** ☒ **Deteriorated**

chimney cond_cracked_loose bricks,
frame adj

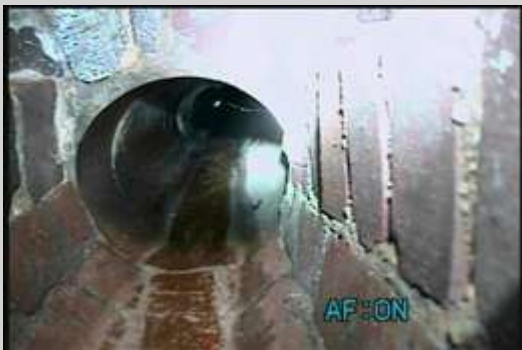
12 O'Clock Outflow

8 in. Circular Gravity Sewer
Pipe Out @ 12 O'Clock

Pipe Material: **Clay** ☐ Pipe Lined

Invert Depth: **8.85** (ft.) Flow Characteristics: **Fast**

Infiltration: **None** Pipe Seal Cond: **Unknown**

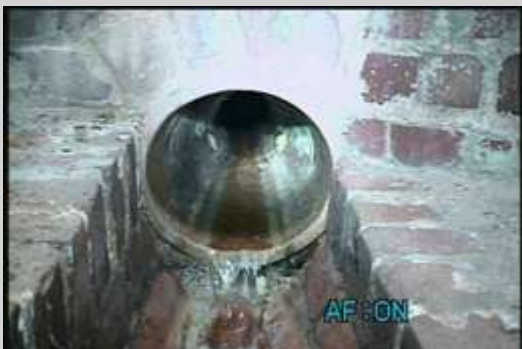
6 O'Clock Inflow

8 in. Circular Gravity Sewer
Pipe In @ 6 O'Clock

Pipe Material: **Clay** ☐ Pipe Lined

Invert Depth: **8.55** (ft.) Flow Characteristics: **Fast**

Infiltration: **None** Pipe Seal Cond: **Unknown**
